No. 2821

Mislabeled ARINC Rack Connectors

SERVICE LETTER

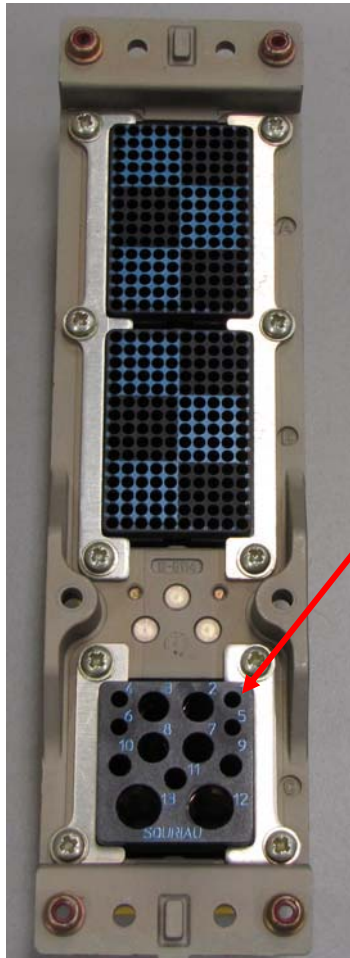
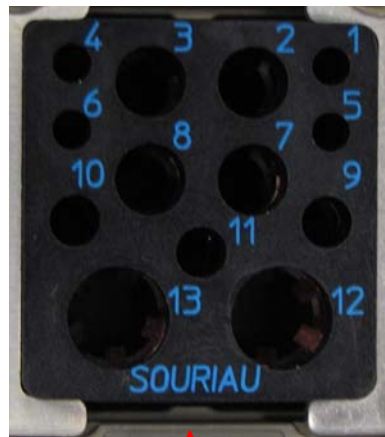
Bottom Plug Power Cavity

Universal Avionics has received several defective ARINC rack connectors from its approved supplier. Several instances of the power cavity bottom plug have been identified as being silk-screened backward and should be returned to Universal for replacement connectors. See the following illustration for the correct markings.

Proper Silkscreen Orientation

If you have UASC Installation Kit Part Numbers **K12075**, **K12036** or **K12028-4**, please inspect these kits for defective ARINC connectors.
